SHELTER AND SETTLEMENTS VULNERABILITY ASSESSMENT – FINAL REPORT

Cyclone Pam Response

VANUATU
MAY 2015

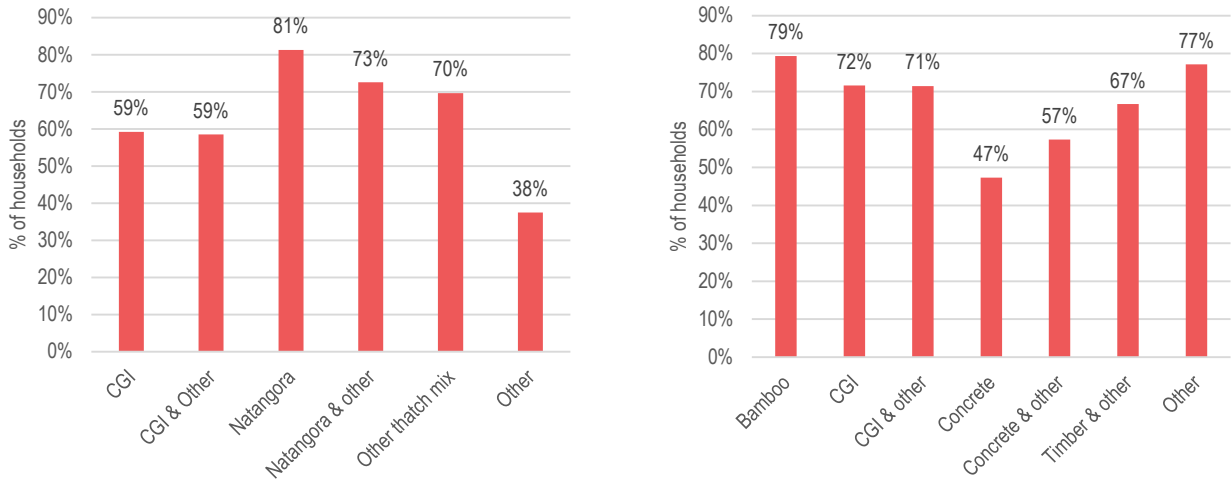
Figure 13: Households reporting temporary displacement by roof materials (left) and wall materials (right)

It can be inferred from data collected on temporary displacement that households were on the whole less confident in their shelter's ability to withstand the high speed winds generated by Cyclone Pam if their roofs were made of natural materials. The vast majority of households whose roofs were constructed from natangora, natangora & other mixes, or other thatch mixes were temporarily displaced to a perceived safer location during Cyclone Pam, 81%, 74%, and 71% of households respectively. A similar pattern can be observed with wall materials. Households with walls constructed from either bamboo or CGI sheets prior to Cyclone Pam were much more likely to have reported temporary displacement than those with walls made from other materials such as concrete, 79% and 72% of households respectively compared to 47% of households overall.

Despite the clear correlation between temporary displacement and shelter materials it should be noted that there are other possible explanations for displacement in the context of Vanuatu. With the community centric culture inherent to Vanuatu, it is possible that temporarily displaced households chose the comfort of being with a group during Cyclone Pam rather than staying in their own shelter. In addition, the decision of households to move to a temporary displacement location could have been influenced by the availability of perceived safe locations, the travel distance required, and the availability of suitable methods of transportation.

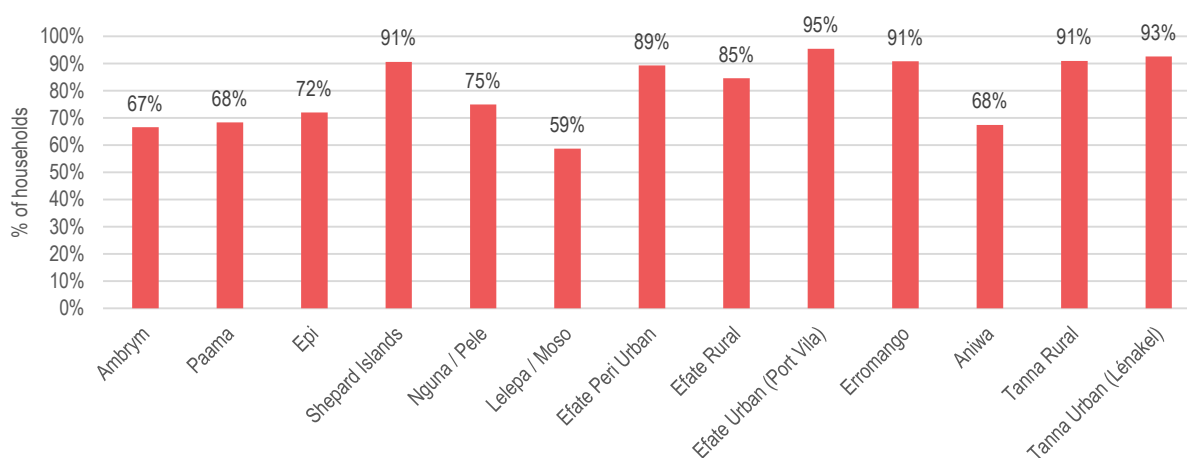
Figure 15: Households reporting damage to shelter

Overall, 81% of households throughout the affected area reported that their shelter had sustained some level of damage as a result of Cyclone Pam. The highest proportions of households reporting that their shelter had been damaged were identified in Efate Urban (Port Vila), 95%, Tanna Urban (Lenakel), 93%, Tanna Urban, and the Shepard Islands, and Erromango, all 91%. These locations are those which were subjected to the highest wind speeds as Cyclone Pam passed through Vanuatu.

It should however be noted that this data takes into account *any* level of damage sustained by a shelter, no matter how small. To gain a more detailed understanding of damage levels across the affected area, REACH teams captured reported levels of damage sustained to core shelter components, roofs, walls, floors, and doors & windows, based on component materials (see *pre-crisis shelter situation* above).

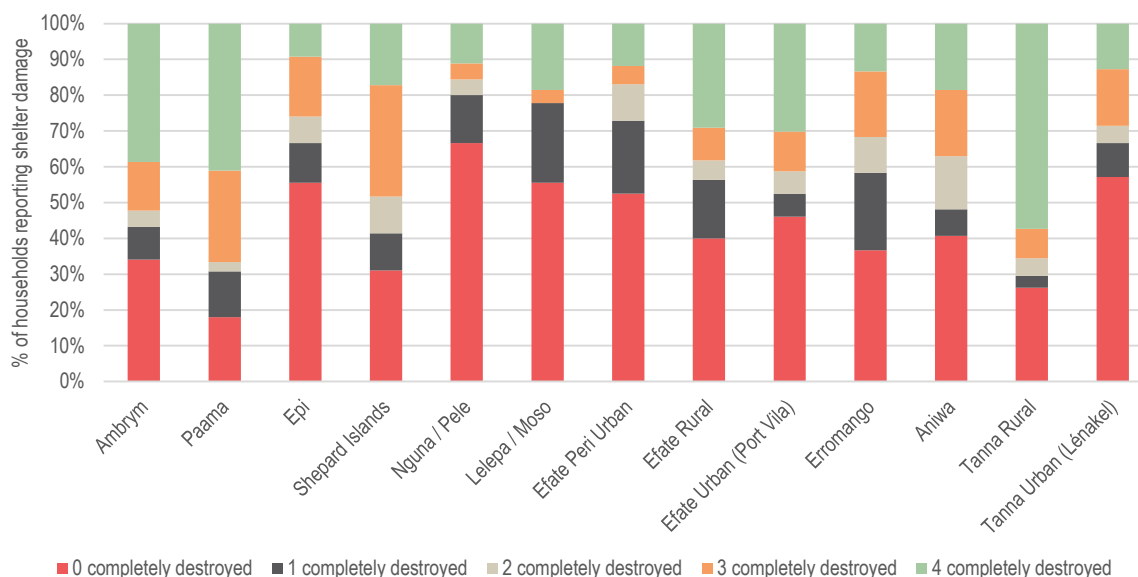
Figure 16: Number of shelter components reported to be completely destroyed

Over half of households across the affected area, 57%, reported that one or more of their core shelter components (roof, walls, floor, windows and doors) was completely destroyed as a result of Cyclone Pam. Using the reported number of shelter components damaged as a proxy for intensity of damage, assessment data suggests that the intensity of damage was highest in Tanna Rural, Paama, and Ambrym, where 57%, 41%, and 39% of households reported that all four core components of their shelter had been totally destroyed during the cyclone.

Conversely, assessment data suggests that the overall intensity of damage was lowest in Nguna / Pele, Tanna Urban (Lenakel), Lelepa / Moso, and Epi, where 67%, 57%, 56%, and 56% of households respectively reported that none of their core shelter components had been totally destroyed during the Cyclone.

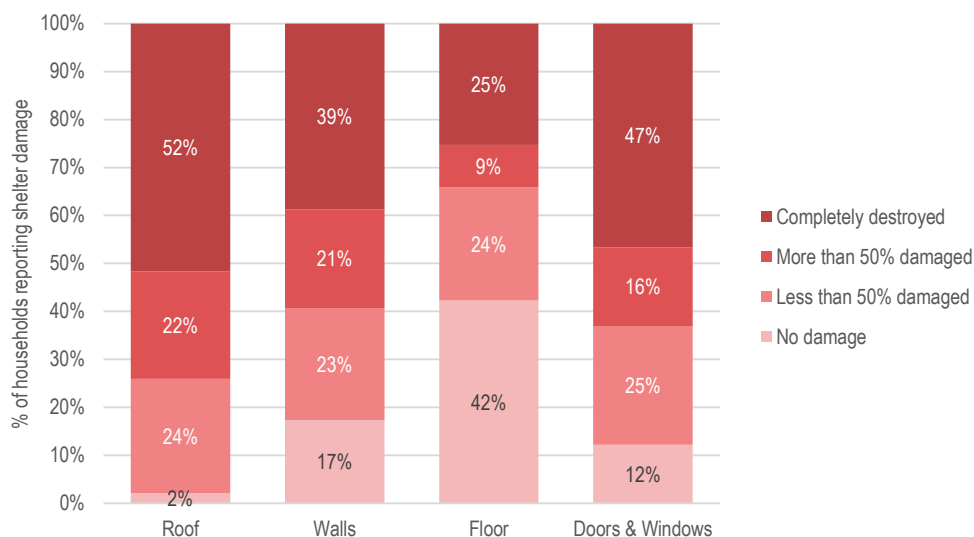
Figure 17: Reported damage by shelter component

Of those households who reported damage to their shelter, over half (52%), across the affected area reported that their roof had been completely destroyed as a result of Cyclone Pam. A further 22% reported that 50% or more of their roof had been damaged, and 24% reported that less than 50% had been damaged. Only 2% of households reported that their roof had sustained no damage during the cyclone. This shows that roofs were the shelter component most vulnerable to the high speed winds generated by Cyclone Pam and represents a potential area of focus for future ‘build back safer’ shelter interventions.

39% of households which were identified as having sustained shelter damage reported that their shelters’ walls had been completely destroyed as a result of Cyclone Pam. Furthermore, 21% reported that 50% or more of their walls had been damaged, and 23% that less than 50% had been damaged. 17% of households reported that their walls had sustained no damage during the Cyclone. As a result, while still having sustained considerable levels of damage, pre-crisis walls appear to have been significantly more resilient to the effects of the Cyclone when compared to roofs.

Floors appear to have been the shelter component which was most resilient to the effects of Cyclone Pam. 25% of households reported that this component had been completely destroyed during the Cyclone. A further 9% reported that 50% or more of their floor had been damaged and 25% reported that less than 50% had been damaged. Finally, 42% of households reported that their floor had sustained no damage during Cyclone Pam.

On the whole, significant damages to doors and windows as a result of Cyclone Pam were identified across the affected area. Almost half, 47%, of the 98% of households which reported having doors & windows prior to Cyclone Pam reported that they had been completely destroyed. Only 12% of households reported that they had sustained no damage to this building component.

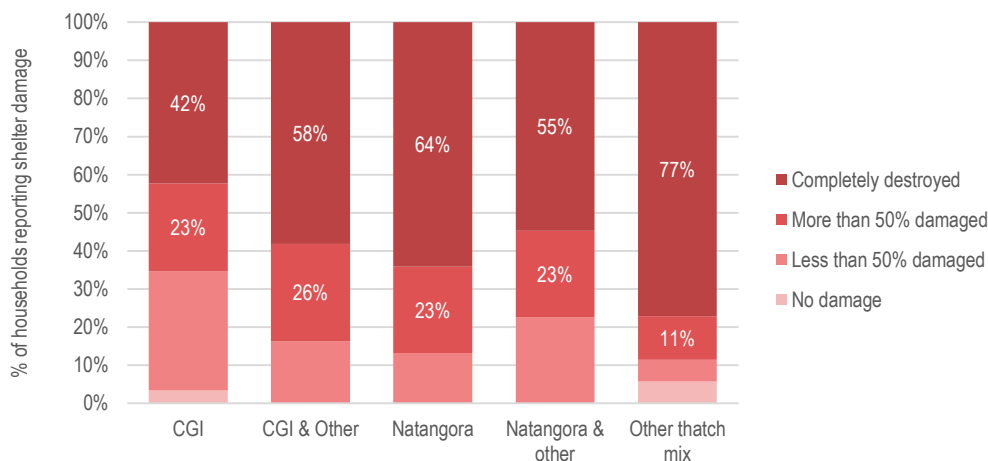
Figure 18: Roof damage, by material

Roofs constructed from thatching leaves other than natangora, for example coconut palms, were identified as having sustained the highest levels of damage. 77% of households which utilised this roofing material for construction reported that their roof had been completely destroyed as a result of the Cyclone. Similarly, both roofs constructed from natangora and natangora & other materials were reported to have sustained high levels of damage, with 64% and 55% of households utilising this material reporting their roofs had been completely destroyed.

Roofs constructed from both CGI and CGI & other mixes were also reported to have sustained high levels of damage as a result of the Cyclone, with the latter being less resilient according to assessment data: 58% of households reported their roofs made of this material were completely destroyed, compared to 42% utilising the former material.

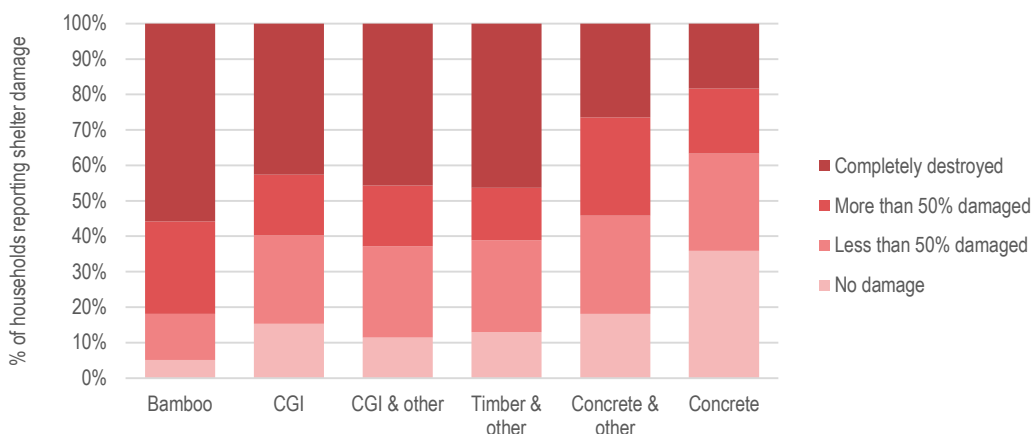
Figure 19: Wall damage, by material

According to assessment data, bamboo walls were the least resilient material to the effects of the Cyclone, with 56% of households that utilised this material for wall construction reporting complete destruction. Furthermore, only 5% of households using this material reported no damage. In addition to bamboo, CGI, CGI & other mixes, and timber walls

Concrete walls were identified as being the most resilient wall material; 38% of households which utilised this material for wall construction reported no damage as a result of the Cyclone, with an additional 27% reported 50% or less damage.

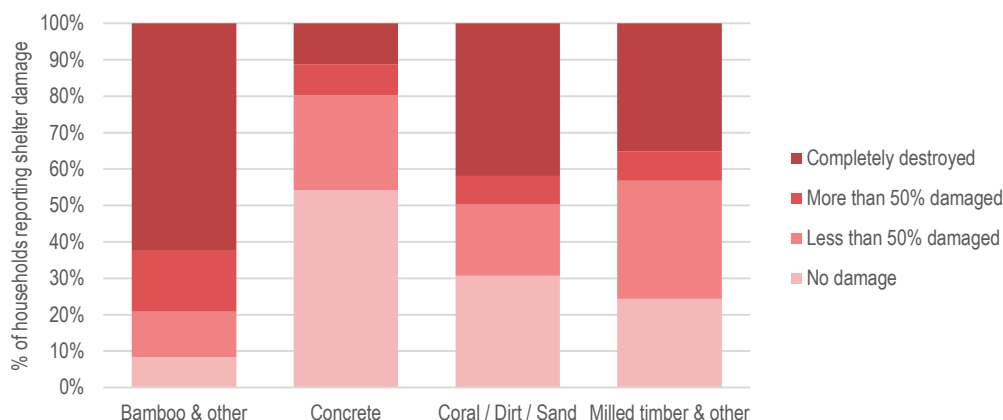
Figure 20: Floor damage, by material

In a similar manner, bamboo was also reported to be the least resilient material for floor construction. 63% of households which had used a mix of bamboo and other materials for construction reported that their floors had been completely destroyed as a result of the Cyclone. In addition, as with walls, concrete proved to be the most durable floor material. Over half, 54%, of households which had used this material in floor construction reported no damage.

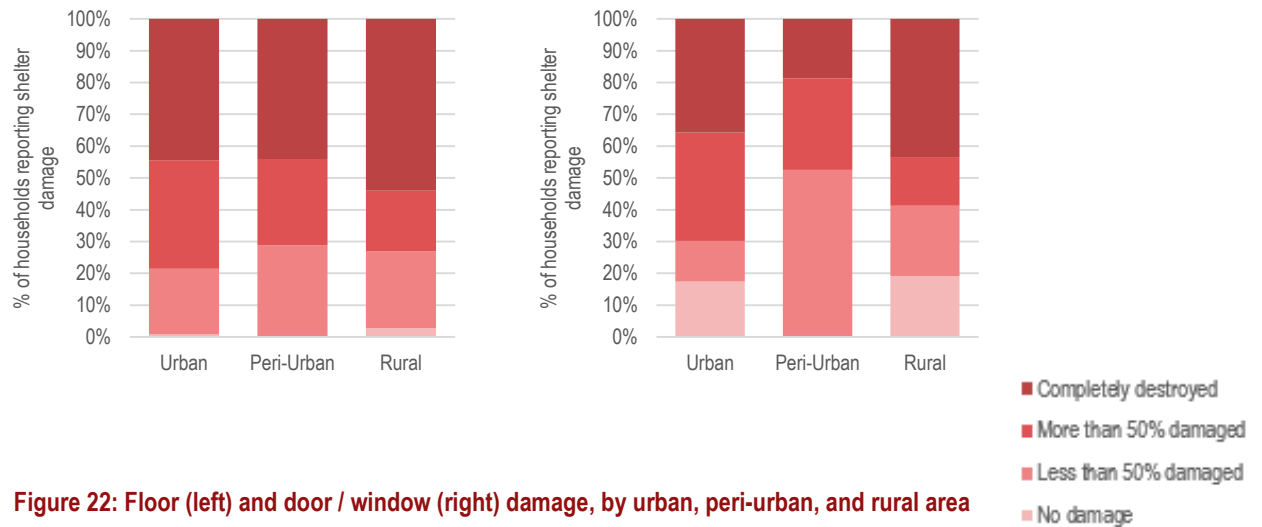
Figure 21: Roof (left) and wall (right) damage by urban, peri-urban, and rural area

Individual shelter components were more commonly reported as completely destroyed in rural locations when compared with urban or peri-urban locations; roofs – 54%, walls 43%, floors, 29%, and doors / windows, 50%. This suggests that in general construction practices in rural locations result in shelters that are less resistant to cyclones than those in urban or peri-urban locations. Interestingly, despite the informal nature of many of the settlements in peri-urban locations, it was more common for individual shelter components to have been completely destroyed or to have sustained 50% or more damage in urban locations compared to those in surrounding peri-urban locations.
