SOUTH KYRGYZSTAN RAPID JOINT SHELTER ASSESSMENT

AN INITIATIVE OF THE SHELTER CLUSTER
03 JULY 2010 / 23 JULY 2010

03 AUGUST 2010 (Updated Figures from December 2010)

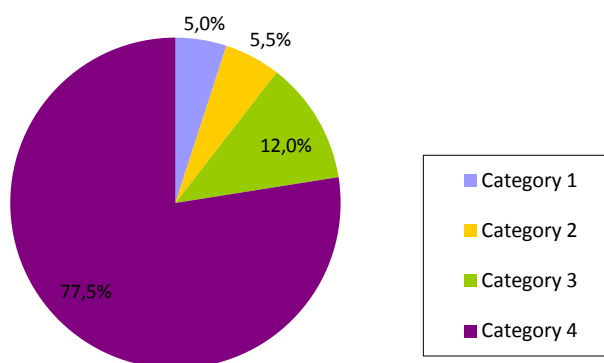
Damaged Houses: breakdown per category

The damaged houses were divided into four categories: (1) minor damage, (2) moderate damage, (3) major damage, and (4) complete reconstruction required. **77.5% of housing units assessed were fully destroyed (category 4).**

Damage Category		
Category 1	97	5,0%
Category 2	107	5,5%
Category 3	233	12,0%
Category 4	1505	77,5%

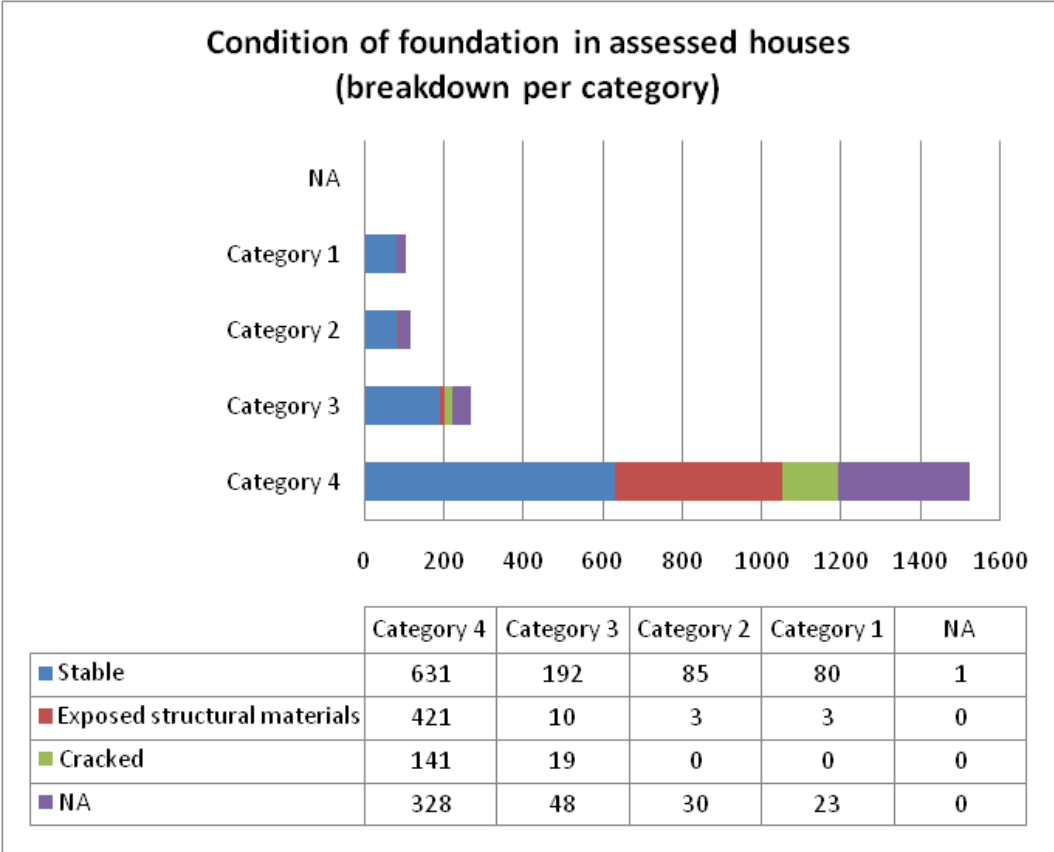
In 6% of assessed houses, structural materials were cracked, while in 22.5% of houses, the structural materials which comprise the foundations were exposed.

Condition of Foundations		
Stable	960	49.4%
Exposed Structural Materials	437	22.5%
Cracked	116	6.0%
Data not available	429	22.1%

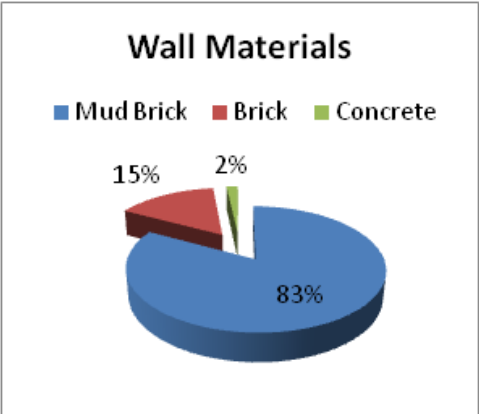
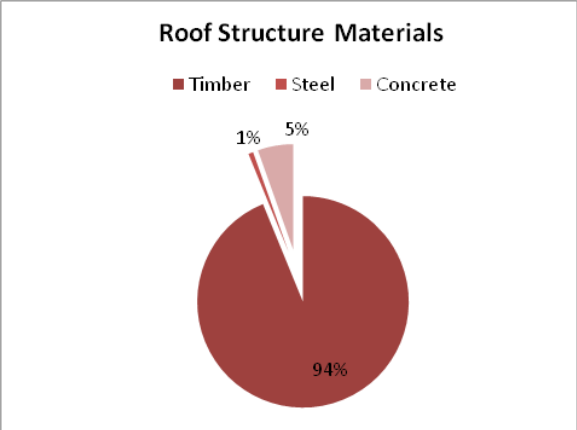
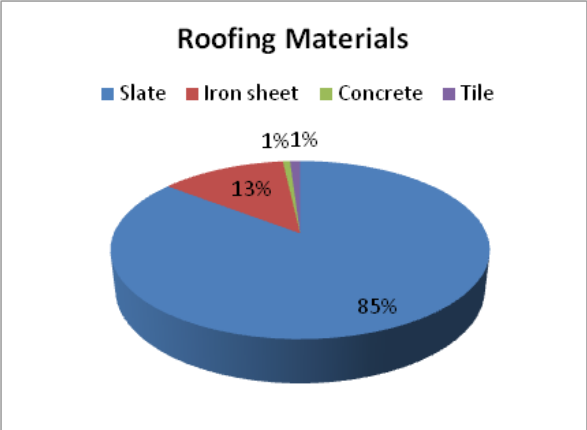
- **Walls:** Approximately 83% of the walls of houses assessed were made out of mud bricks, and 85.2% had plastering over the wall materials.
- **Roof materials:** Slate was the primary roofing material used for assessed houses (85%).
- **Roof structures:** The structure of most roofs was made from timber (94%).
