SHELTER AND SETTLEMENTS VULNERABILITY ASSESSMENT – FINAL REPORT

Cyclone Pam Response

VANUATU
MAY 2015

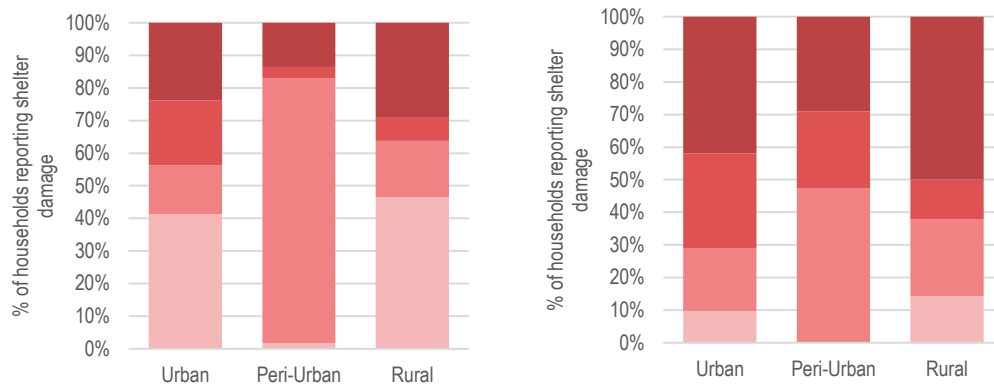
Figure 22: Floor (left) and door / window (right) damage, by urban, peri-urban, and rural area

Floors appear to have been the shelter component which was most resilient to the effects of Cyclone Pam. 25% of households reported that this component had been completely destroyed during the Cyclone. A further 9% reported that 50% or more of their floor had been damaged and 25% reported that less than 50% had been damaged. Finally, 42% of households reported that their floor had sustained no damage during Cyclone Pam.

On the whole, significant damages to doors and windows as a result of Cyclone Pam were identified across the affected area. Almost half, 47%, of the 98% of households which reported having doors & windows prior to Cyclone Pam reported that they had been completely destroyed. Only 12% of households reported that they had sustained no damage to this building component.

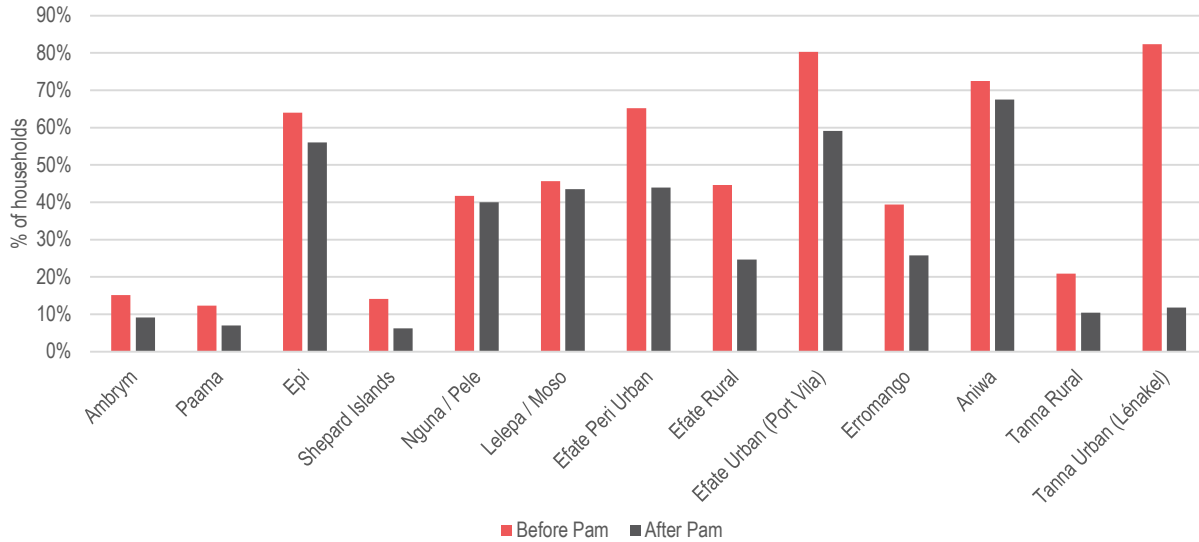
Figure 23: Households with access to electricity before & after Cyclone Pam

Prior to Cyclone Pam, 46% of households across the affected area reported they had electricity in their homes. Of this proportion over half of households, 54%, reported that electricity supply came from solar panels installed on their roofs. Only a minority of households was able to access electricity supply from the grid, 38%. Despite almost half of households having an electrical supply to their shelter prior to Cyclone Pam, there are significant variations between different geographic locations; ranging from only 12% of households in Paama, to 82% of households in Tanna Urban (Lenakel).

The most significant damage to electricity supply was observed in Tanna Urban (Lenakel). As above, 82% of households reported that they had received electricity supply at their shelter prior to Cyclone Pam (primarily from their grid, 72%). However, as a result of the Cyclone this proportion had fallen to only 12% of households at the time of the assessment⁴.

⁴ Note: significant repair works to the grid were being conducted by Unelco (Vanuatu's private utilities provider) at the time of the assessment. It is therefore highly likely that grid electrical services have now been, at least partially, restored.

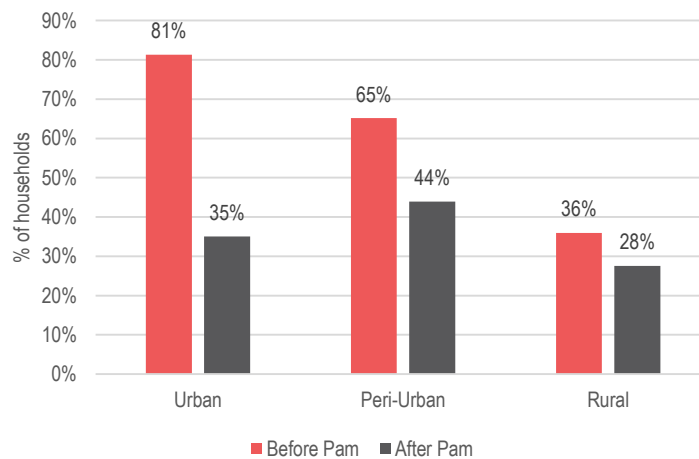
Figure 24: Households reporting access to electricity supply by urban, peri-urban, and rural area

Electricity supply to shelters was significantly more common in urban and peri-urban locations prior to Cyclone Pam, 81% and 65% respectively, compared to only 36% in rural locations. This can be explained by the almost universal absence of electrical grid infrastructure in the vast majority of rural locations throughout the affected area and the high start-up costs associated with installing solar panels on roofs.

Electricity supply was most severely affected in urban areas, with a 57% decrease in the proportion of households reporting electricity supply at their shelter as a result of the cyclone. Where households did have electricity at their shelters in rural areas, only a 23% decrease in availability was reported. This can be explained as a result of 88% of these households relying on solar power and thus having the ability to store roof panels in a safe location during the cyclone and re-install in the aftermath.

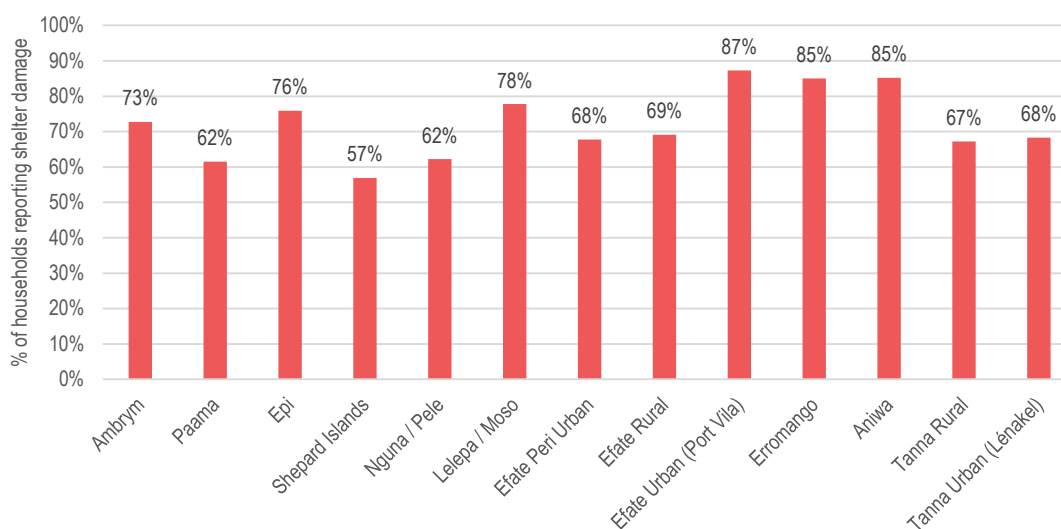
Figure 25: Households reporting having completed substantial shelter repairs or reconstruction

Confirming anecdotal evidence of rapid recovery throughout the affected area of Vanuatu, where many affected households were reported to have quickly rebuilt at least a makeshift shelter in the immediate aftermath of the cyclone, 72% of households reported that they had completed substantial repair / reconstruction work on their shelter by the time of assessment⁵. Indeed, rapid recovery was identified in all assessed locations, with proportion of households having completed substantial repairs ranging from 57% in the Shepard Islands, to 87%, in Efate Urban (Port Vila).

The difference in recovery rates within this wide reported range can be explained by the significantly higher ability of households in Efate Urban (Port Vila) to access materials and tools required for repairs and rebuilding in local markets. In contrast, the Shepard Islands is almost wholly reliant on local boat transportation for such materials and tools, which was severely disrupted as a result of the cyclone due to damage to boats.

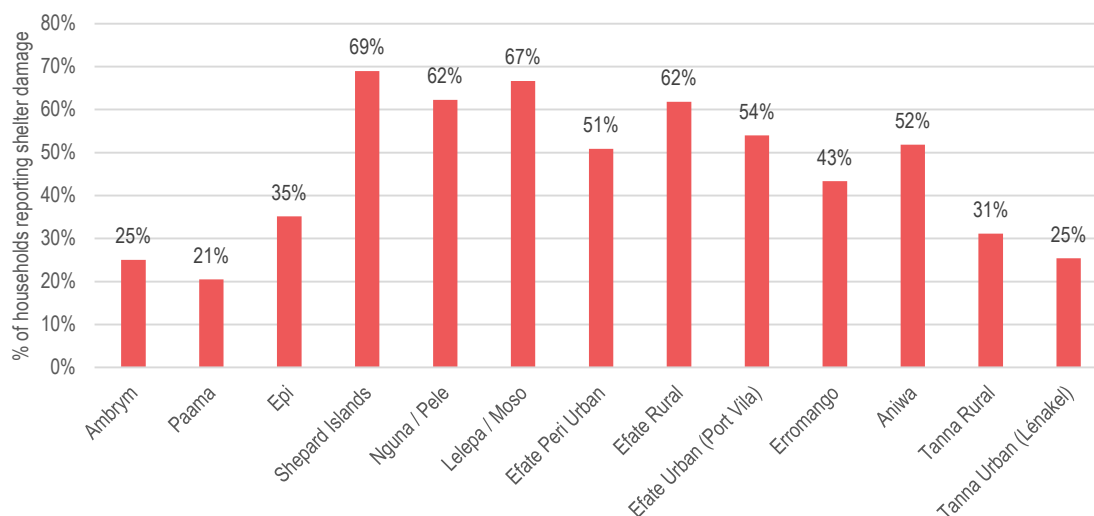
Figure 27: Households reporting being able to use recovered materials for shelter repair / reconstruction

Less than half of households, 45%, reported that they could recover materials in a condition suitable for use during repairs or reconstruction. However, this proportion was found to vary considerably by location. Households in the Shepard Islands, Lelepa / Moso, and Nguna / Pele most commonly reported that they were able to recover suitable materials, 69%, 67%, and 62% of households respectively. Conversely, in Paama, Tanna Urban (Lenakel), and Ambrym the prevalence of households with the ability to recover suitable shelter materials was the lowest, 21%, 25%, and 25% respectively.

Pre-crisis roof materials in the Shepard Islands, Lelepa / Moso, and Nguna / Pele were predominately made of CGI and walls of either CGI (Lelepa / Moso and the Shepard Islands) or concrete (Nguna / Pele). While in Paama, Tanna Urban (Lenakel), and Ambrym roofs were most commonly constructed with natangora, natangora & other mixes, or other thatching and walls from bamboo. This suggests that CGI and concrete slabs, while still being vulnerable to the effects of high winds during a Cyclone, are significantly easier to recover in a suitable condition for repairs and reconstruction than natural materials such as natangora, other thatching, and bamboo.

The significant time it will take for communities in the affected area to re-establish stocks of natural building materials, for example natangora, bamboo, and other thatching leaves, represents an additional potential for increased vulnerability. Shelter interventions should therefore support both the re-establishment of natural building material stocks and facilitate the delivery of such materials from other locations not significantly affected or unaffected by Cyclone Pam.

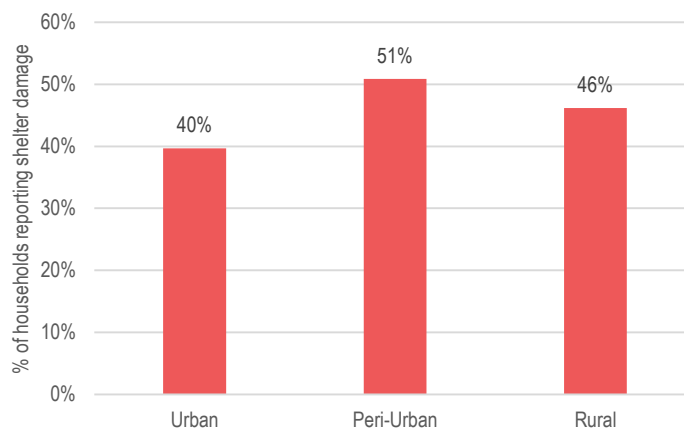
Figure 28: Reported ability of households to use recovered materials for shelter repair / reconstruction, by urban, peri-urban or rural area

By a small margin, households in urban locations more commonly reported that they were unable to recover suitable materials to conduct shelter repairs or reconstruction (60%) than their counterparts in peri-urban or rural locations, 49% and 54% of households respectively.

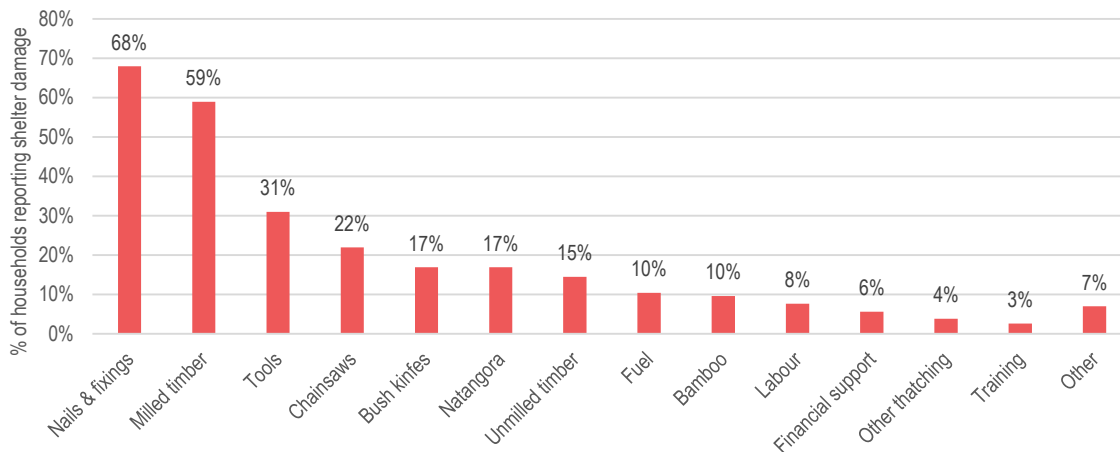
Figure 29: Reported needs for shelter support for repair / reconstruction

The most commonly reported resource required for the repair and reconstruction of shelters was nails and fixings, with 68% of households across the affected area reporting a need for this type of shelter support. Considerable proportions of households reported a need for milled timber, tools, and chainsaws, 59%, 31% and 22% respectively. Only a minority reported that they required labour, financial support, or training, to repair or reconstruct their shelter; reported by 8%, 6%, and 3% of households respectively. This highlights that households perceive that they will be able to self-recover given access to key materials and tools, with little to no external support.

However, this does not preclude a shelter response which includes training support. Despite the seemingly widespread perception amongst households that they do not require training support, the fact that households have reported

rebuilding with the same pre-crisis materials highlights a potential for future vulnerability. As such, this situation presents an opportunity for 'build back safer' interventions to be included in the Shelter Cluster response strategy.
